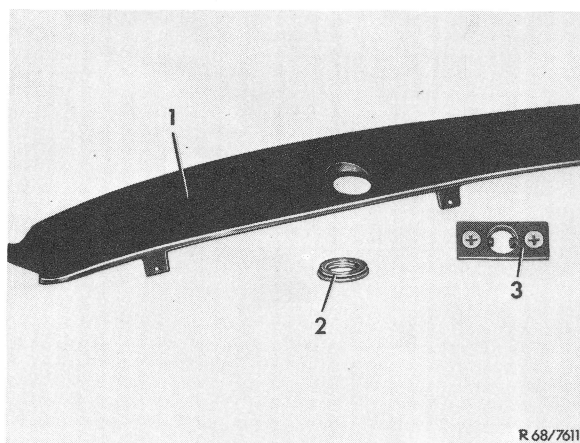
Fig. 1

- 1 Windshield header molding      3 Guide bearing  
2 Washer

- 1 Unscrew windshield header molding (1) from front panel frame.

- 2 Remove both guide bearings.

- 3 Install modified guide bearings (3).
- 4 Insert washers (2) into the two bores of windshield header molding (1) (Fig. 1).

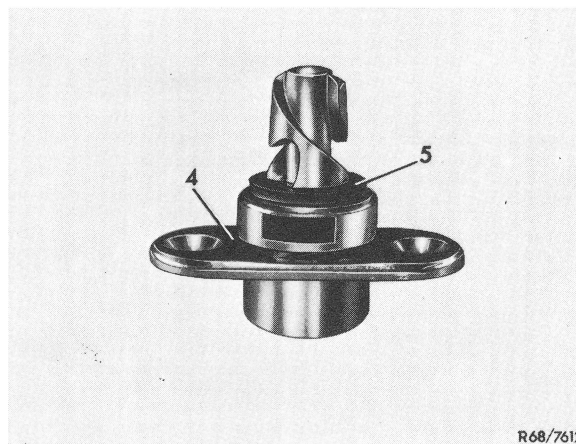
Fig. 2

- 4 Catch      5 Plastic washer

**Note:** The top catch can also be installed in types of model series 113. On these vehicles, however, each catch should be fitted with an additional plastic washer Part No. 111 776 80 97.
