### Conventional tool

Cylinder illuminating lamp

103 - 15-713

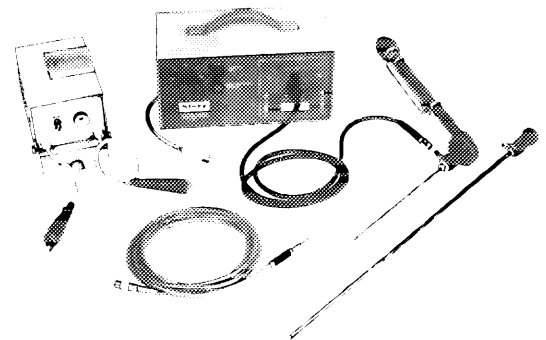
With a cylinder illuminating lamp it is possible to carry out the visual check while the cylinder heads are installed.

To evaluate the cylinder bore, the lens probe is introduced through the spark plug bore while the respective piston is at BDC position.

To check cylinders with difficult access (left engine side), the lens probe 10326 CT (210 mm) must first be introduced into the spark plug bore before connecting it to the extension.

Motoskop TW  
12 volts and 220 volts
